# Cassini-Huygens Probe On-Pad Cooling Incident

## Report of Formal Review Board

October 27, 1997

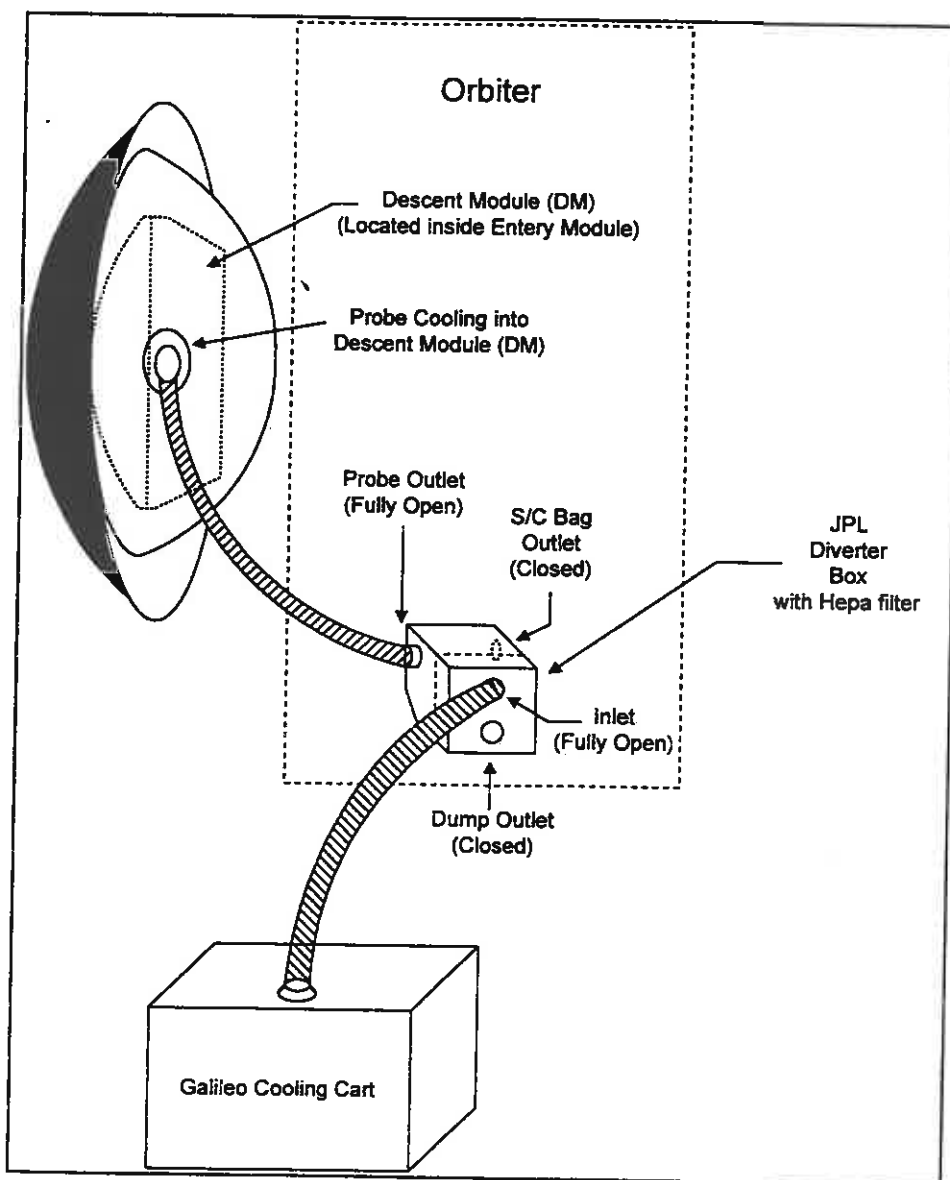
The configuration of the probe cooling at the PHSF prior to being transported to the launch pad (LC-40) is given in the following figure:

Just prior to the transportation the GLL cooling cart was disconnected from the inlet hose and the inlet valve was closed. During transportation to LC-40 no cooling was supplied. When arriving at LC-40 the S/C bag outlet was open a 1/4 way and the inlet valve was open fully, then the level-7 air conditioning hose was connected to the inlet hose. This was configuration during the lift of the S/C to level-14. Once at level-14 the level-13 A/C hose was connected to the inlet hose. The noise from the diverter box was too loud from a safety stand point so the flow

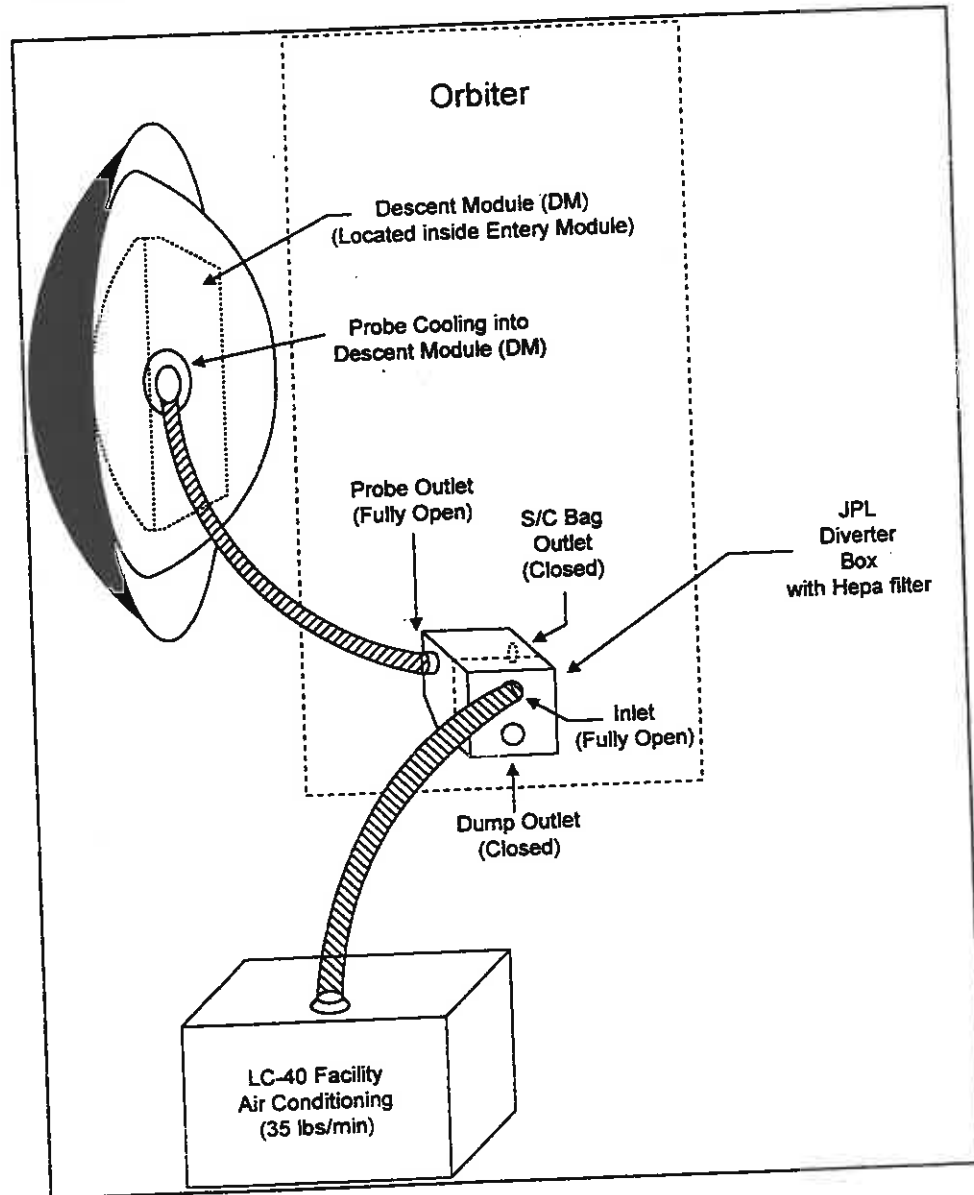
rate of the facility was reduced and the S/C bag outlet was closed. At this time the flow rate into the Probe was approximately 30 lbs/min. This flow rate was too low for the facility to maintain the air temperature control. P. Hoffman called G. Coyle and J. Wirth to state the problem and notify that the flow rate had to be increased to 35 lbs/min. The following figure shows the Probe in the worst case configuration.

On Friday (8/29/97) morning the question was raised to ESA of what the requirement of flow rate into the Probe was. After talking to specialist in Europe it was discovered that the 35 lbs/min was too high. On Friday afternoon the flow rate into the probe was adjusted to ~ 8 lbs/min with ESA's concurrence.
